NIOSH
Fire Fighter Fatality Investigation
and Prevention Program

Volunteer Captain Killed in Fire Apparatus Crash While Responding to a Training Exercise - Oregon

Fatality Assessment and Control Evaluation Investigative Report #F2003-14

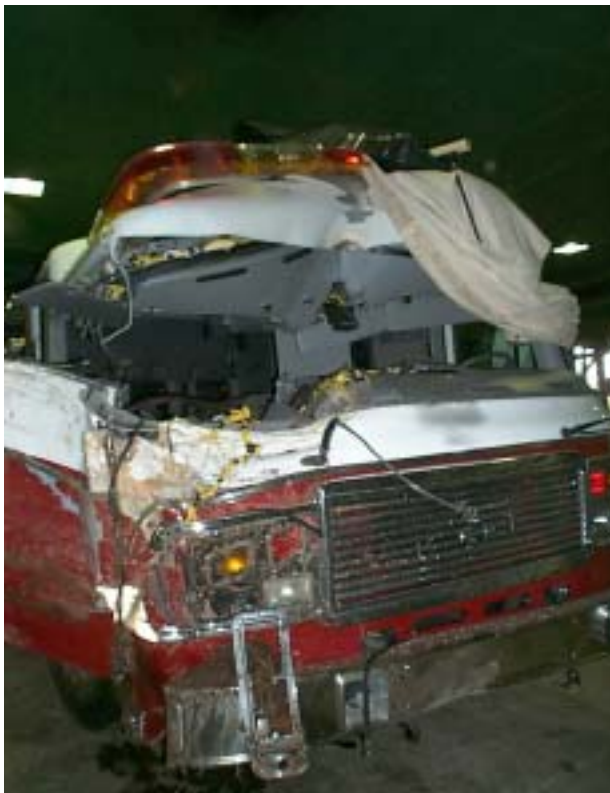
Engine involved in the incident

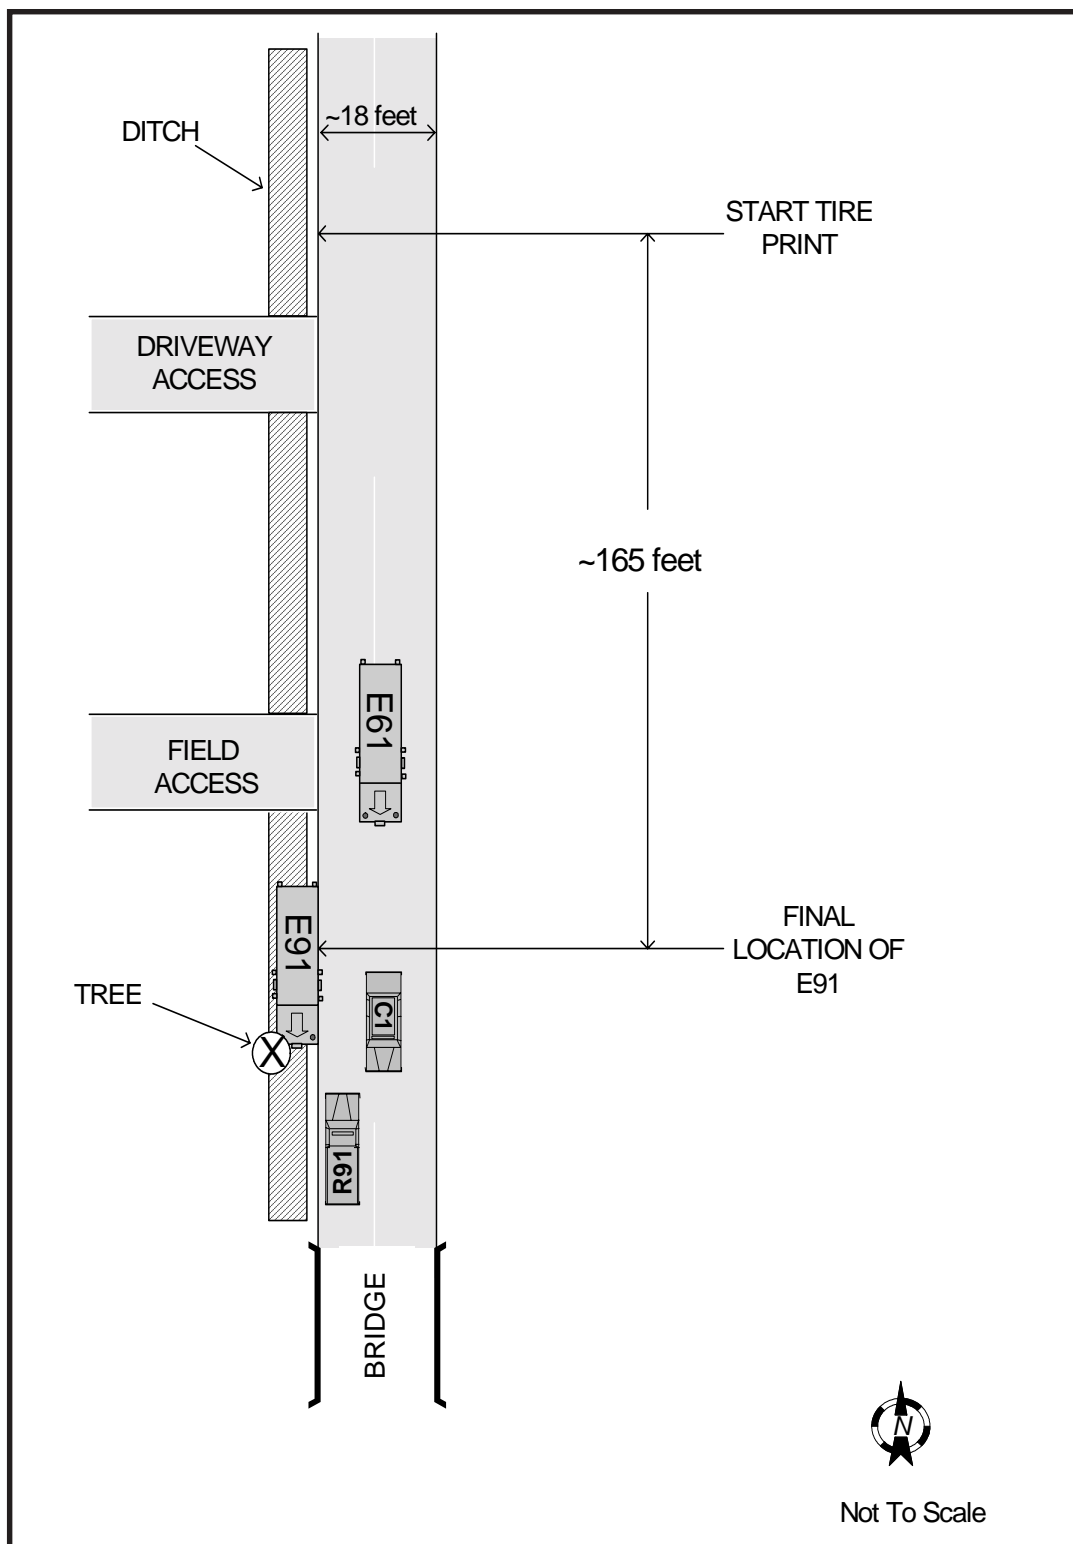
Diagram. Aerial view of the incident scene

that was at the same level as the road and perpendicular to the ditch. The engine bounced over the driveway and back into the ditch where it hit a second driveway leading to a field. The engine again bounced over the second driveway (field access) and reentered the ditch where it slid into a tree and came to rest in the ditch (Diagram, Photo 3).

The Assistant Chief of Operations arrived in Car 1 (C1) and parked in the middle of the road towards the front of E91 (Diagram). The Battalion Chief and firefighters from R91 responded from the training site and positioned their apparatus in front of C1. The Assistant Chief of Operations was assisting R91, and they formed two crews and attempted to use their hydraulic tools to free the victim. Due to R91's positioning, the lines for the hydraulic tools were too short to reach the victim's apparatus on their initial attempt. After the crews extended the lines, both tools malfunctioned and went out of service. One tool was repaired and the Battalion Chief was having extreme difficulty cutting the roof away from the cab due to the cab being reinforced with layers of aluminum (Photo 4).

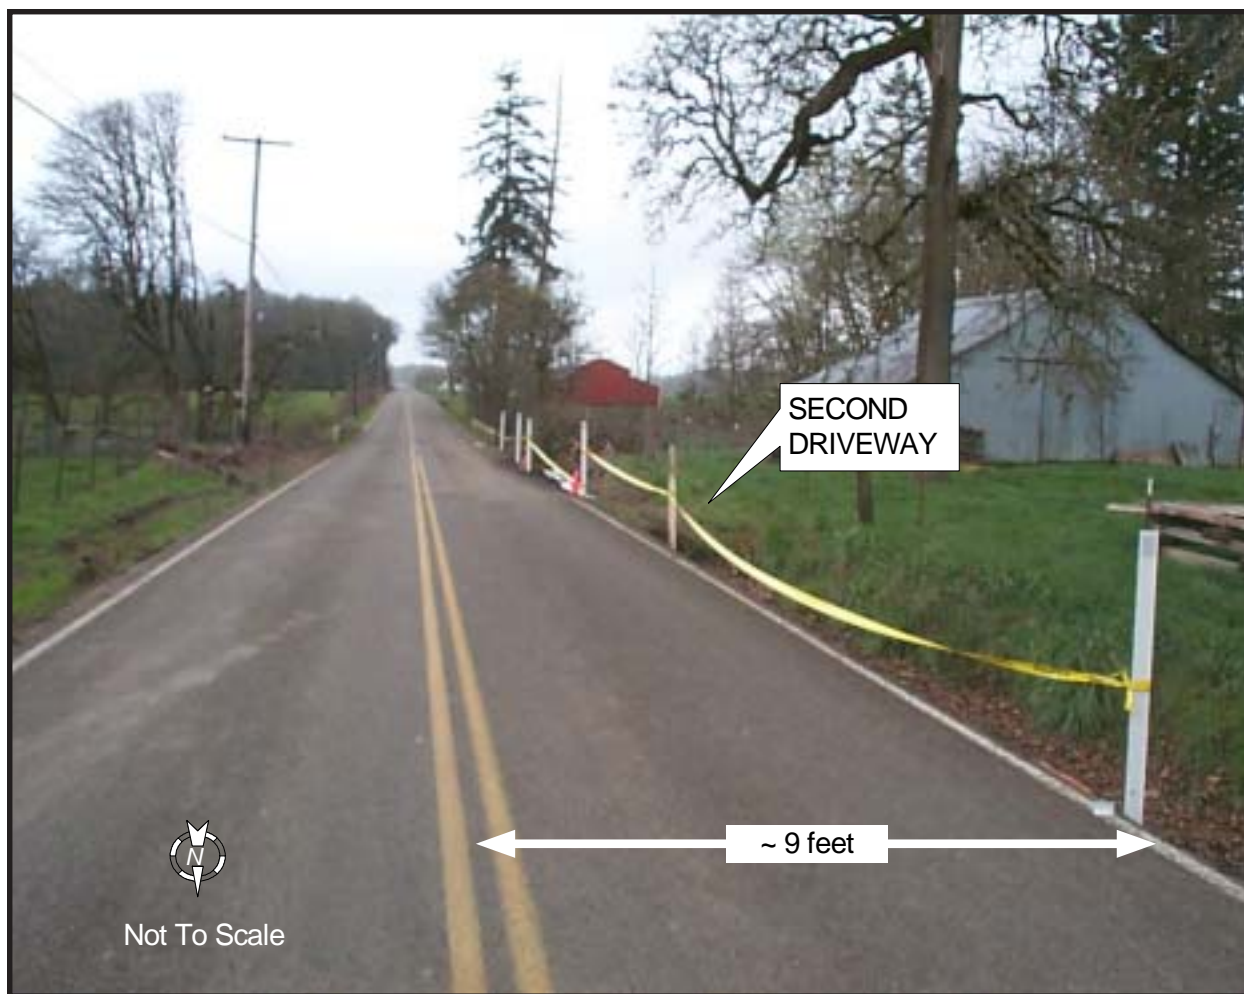
The incident occurred at approximately 1947 hours on a two-lane county roadway with a posted speed limit of 35 mph. A light rain was falling at the time of the incident. The ambient temperature was approximately 50° Fahrenheit. The asphalt roadway did not have a shoulder. A grassy ditch approximately 40 inches deep paralleled the road. The base for the roadway was recycled asphalt. Each lane was approximately 9 feet from the double-yellow center lines to the white fog line on the side of the road (Photo 1).

The planning staff for developing emergency scene risk management must identify items such as water supply problems, exposures, site accessibility, street conditions, potential for apparatus delays, and any other specific hazards that may relate to the site. One main consideration in pre-planning is to ensure that all members arrive on the scene safely. Just as SOPs enhance and augment fire department operations and training, pre-planning and identifying potential hazards is crucial to eliminating risks that may be encountered on the fireground, or while responding to the incident. All available routes should be considered when pre-planning a response to a site. Some routes, especially in rural areas, may only be considered under emergency situations due to their size, capabilities, and conditions. The road used to respond to the training site was a two-lane road with each lane approximately 9-feet wide and without shoulders. The apparatus was approximately 8 feet 6 inches wide not including the side mirrors. Driving the apparatus on this road at night without lights and sirens created a right-of-way issue in which the driver/operator had approximately only 3 inches per side to negotiate staying within the lane.

Photo 1. Divided asphalt roadway

Recommendation #3: Fire departments should develop a pre-incident planning program to include deployment of resources.^{7, 8, 9}

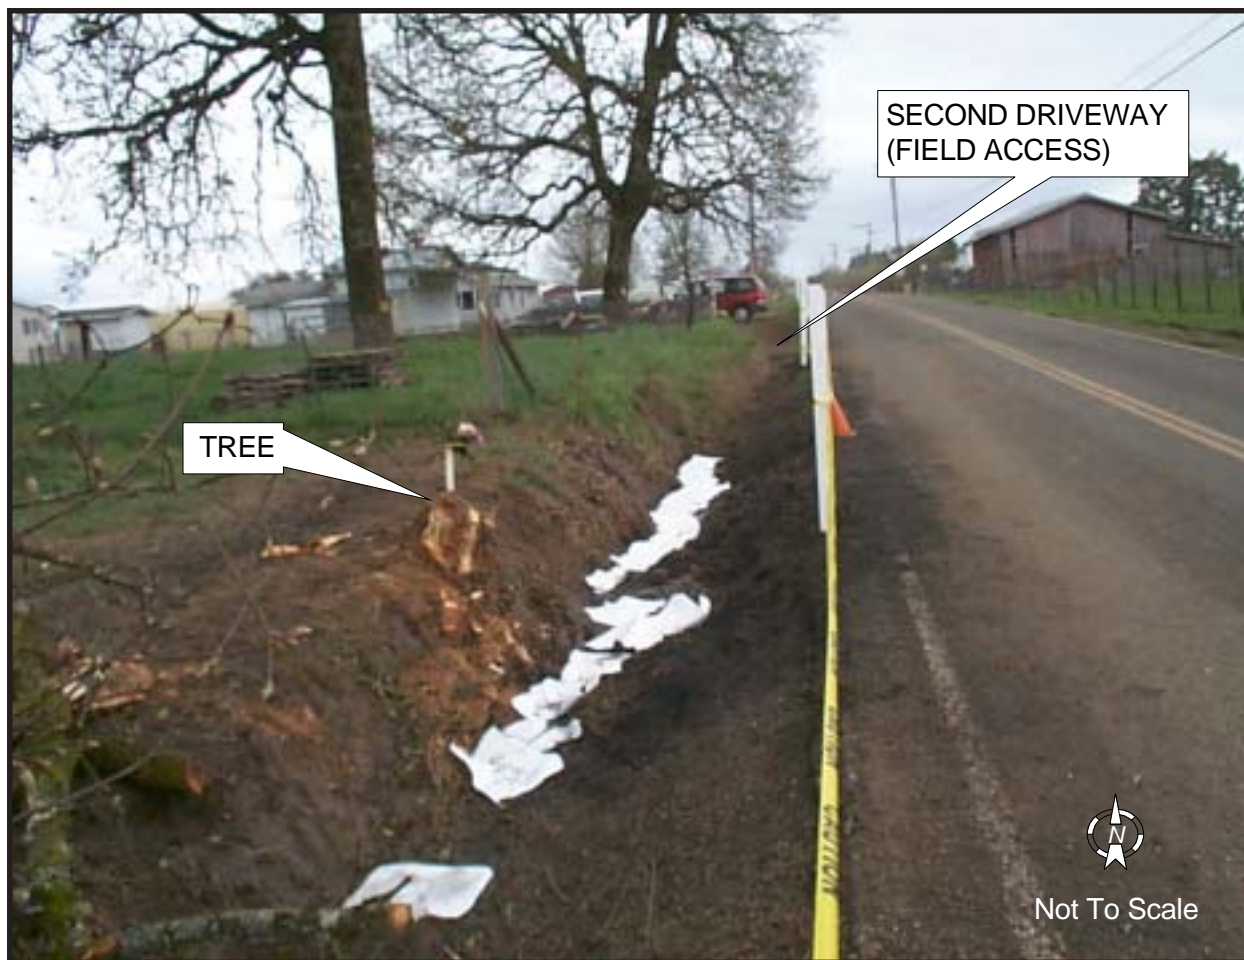
Photo 3. Incident site

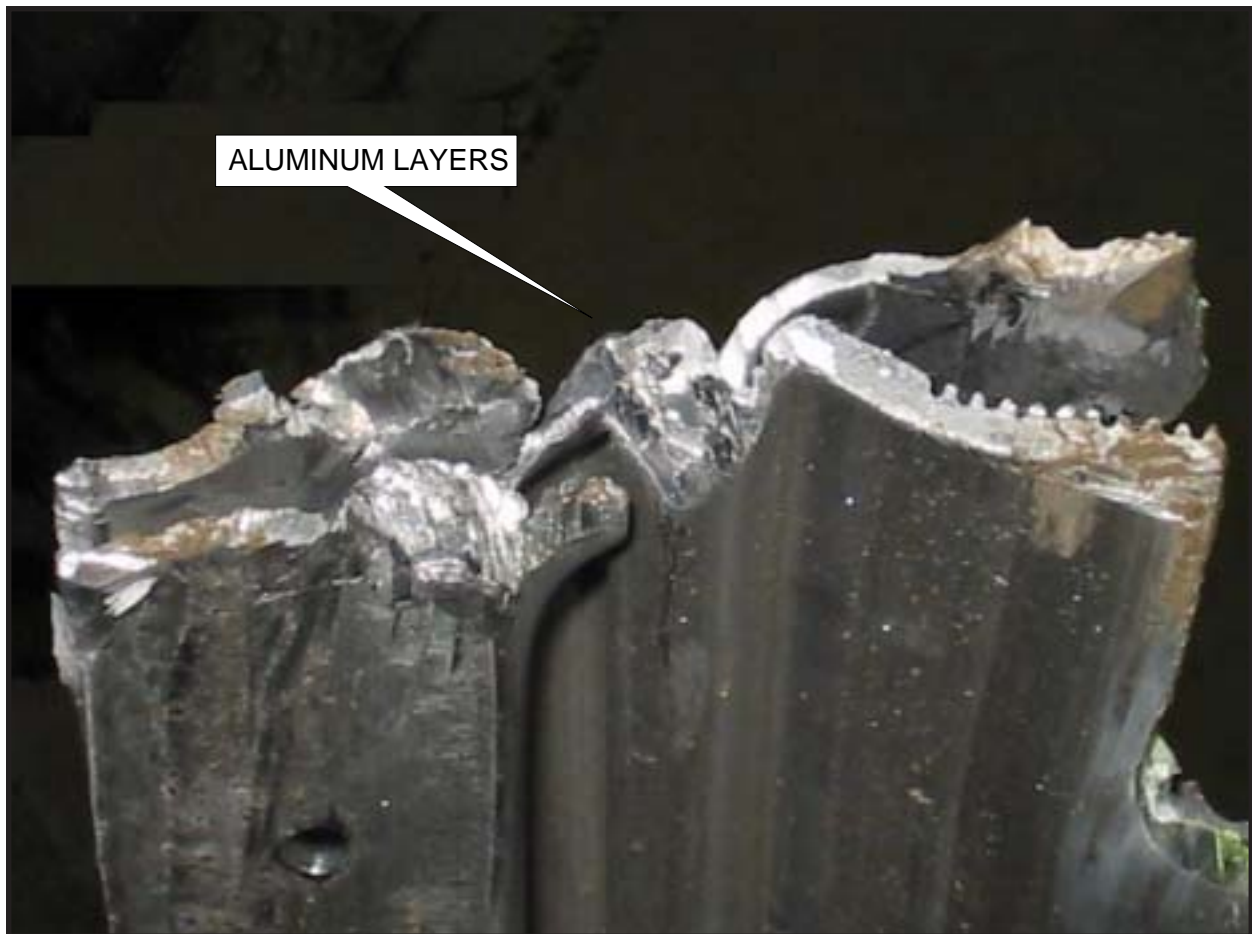
Photo 4. Reinforced Aluminum
